Common problems and solutions

catalogue

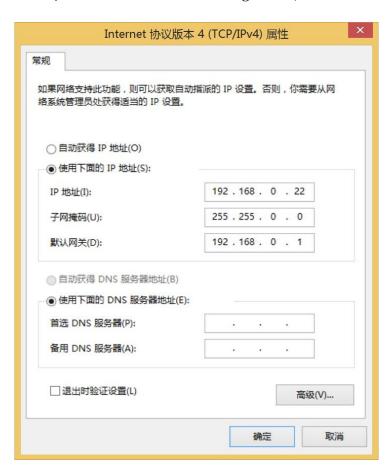
(1) Check whether the computer local connection (Ethernet) ip address is correct, as shown in the figure. (Error code 20008)

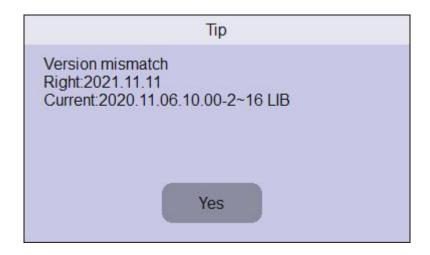
2 System mismatch, please device upgrade or version mismatch

- (1) Click OK to enter the device upgrade interface, open the corresponding version of the software folder, and open the Mac_Update.zar document. (Do not close this error reporting interface, you must click OK.)
 - (2) Ererror after equipment upgrade, please upgrade firmware.

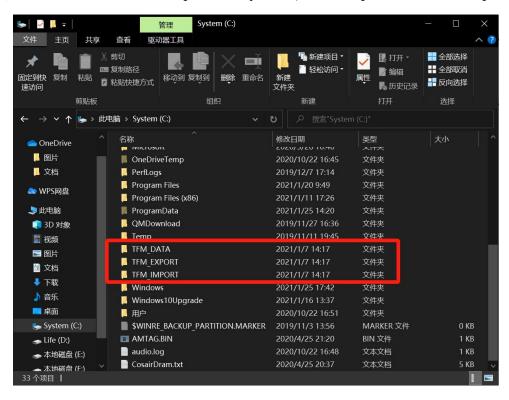
3 Open the software flash back or the interface display is incomplete

- (1) Close the software, open the computer C disk, and delete the three folder of TFM DATE, TFM EXPORT, and TFM IMPORT files.
- (2) Close the software, open the software folder, and delete the FH PROJECTOR. CFG document.
- (3) Reload the software, and then delete the computer C disk TFM_DATE, TFM EXPORT, TFM IMPORT three folders.
 - (4) Reinstall the computer system, or replace the computer.

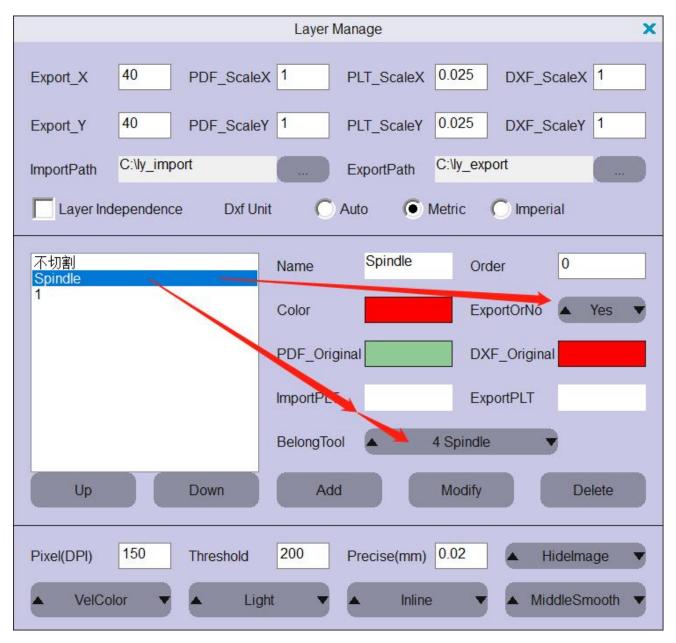
(6) Whether the spindle output in the layer is open.

(7) Correct whether "output enable is on" is checked.

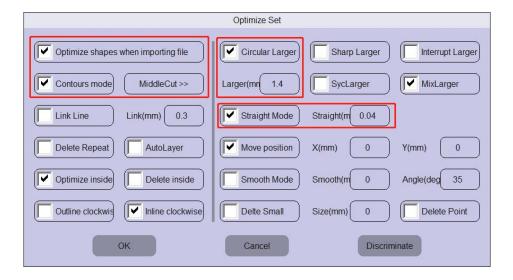
Layer management changes to be The low or smooth. not optimization option is too large.
